Construction of Earthquake Resistant Buildings and Infrastructure Implementing Seismic Design and Building Code in Northern Pakistan 2005 Earthquake Affected Area

Keywords: Earthquake, Building Structures, Infrastructure, Building Code, Seismic design, Pakistan

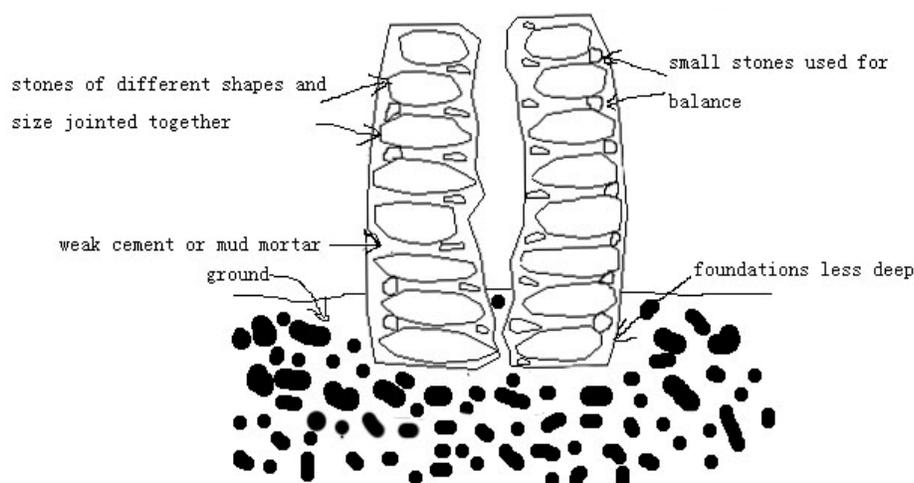
Wall section of stonework building structures

In Pakistan (which is a development country) most of the building structures are made up of unreinforced masonry like concrete blocks, which are not good at resisting to earthquakes. Foundations were constructed mostly of stones or bricks bearing on native soils around 3-4 feet below ground and around 18-24 inches wide. A few steel structure found in most of the wall construction is in lintels (window or door headers). In most cases, it was found that no good ties existed between the walls and the floors and roofs. In the affected area, wall construction of the most buildings, were of non-engineered and non-durable stonework. AJK, 2006. The performance of these buildings in the earthquake was varied and heavily depended on factors like redundancy in structural walls and quality of materials used and construction techniques. In areas of strong ground shaking, most of the stonework wall structures collapsed or intensely damaged. The majority of these structures were constructed of round stones with mud or weak cement mortar. This type of construction had poor block strength and weak mortar. There was absence of seismic detailing which means to construct a building in such a way that the building is less vulnerable to earthquakes or seismic shocks. Generally, the building structures with fired-clay bricks masonry had better performance than other types of wall constructions in the case of earthquakes. FRC, 2006.
